**AirCare Technician Exam Sample Questions  
2008**

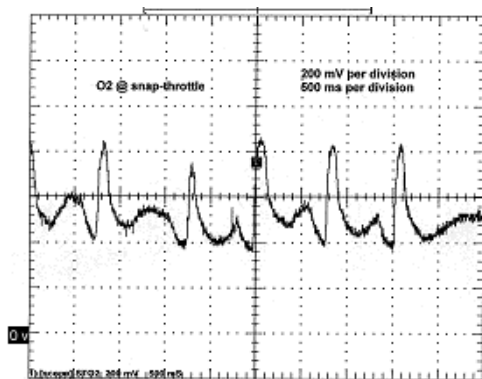
2. The following O<sub>2</sub> sensor waveform is taken while performing a series of snap-throttle tests on a 1993 vehicle with a 2.2 litre port fuel injected engine.

What does this waveform indicate?

- a) Normal O<sub>2</sub> sensor range and response with a possible fuel system problem causing mixture to stay rich on deceleration
- b) Limited O<sub>2</sub> sensor range and response requiring O<sub>2</sub> sensor replacement
- c) Normal O<sub>2</sub> sensor range and response
- d) None of the above
